PROJECT SUMMARY

Project Name:	Sunroof Assembly Line Updates
Total Value:	\$512,648
Hours:	Over 3500
Engineers:	One (1) – Electrical design One (1) – Mechanical design Two (2) – Software Design Two (2) – Commissioning
Market:	Automotive
Manufacturing/Process:	Process Automation
PLC:	Rockwell – ControlLogix
SCADA:	Rockwell – RSView ME
Motion:	Robocylinder
Robot:	ABB
High End:	Visual Basic

OTI was contracted by an automotive sunroof manufacturer to design, build, and install the necessary electrical, pneumatic, and mechanical systems to retrofit the an existing sunroof assembly line to process a new sunroof module.

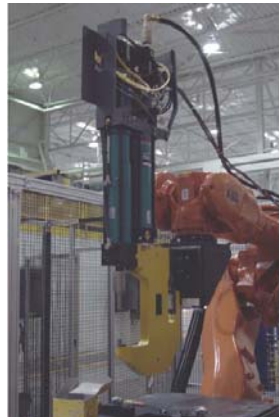
Station FA20 (Auto TOX)

- New hold down clamp details
- Add software (PLC logic, HMI) configuration for new model
- Teach new TOX points
- New part locating pin details through mounting holes (front, rear, LH & RH)

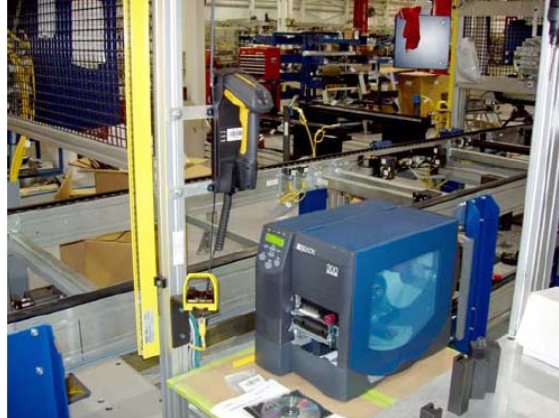
Station FA40 (Trim Lace Install)

- Change Trim Lace track to accommodate new model
 - Change all details to quick change
-

- Add sensor for track orientation
- Add new color sensor
- Print birth certificate
- Scan bar code label

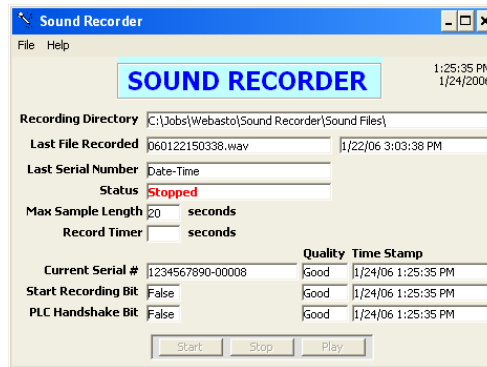
Sound Recording

A custom application was created in Visual Basic that uses several microphone inputs through a sound mixing board to audibly monitor the operation of motors in each product being manufactured. The sound files are collected, compressed and stored in individual files by serial number in real time.

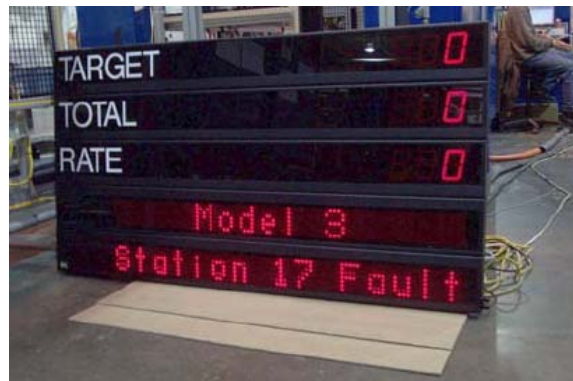
Marquee

A custom Visual Basic application was modified to monitor the status of the current production run and update a 5 line marquee board over an Ethernet TCP connection.
